# BATTERY POST ABUSE SAMPLES

"First Battery only warrants that this Battery is free of defects in material and workmanship under normal use and service conditions and in terms of correct application." Thus using batteries for any other purpose than the correct application will void the warranty. Battery casing and Posts can give a good indication as to the use and abuse of the battery.

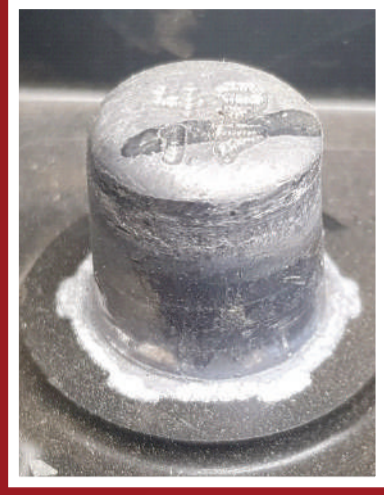
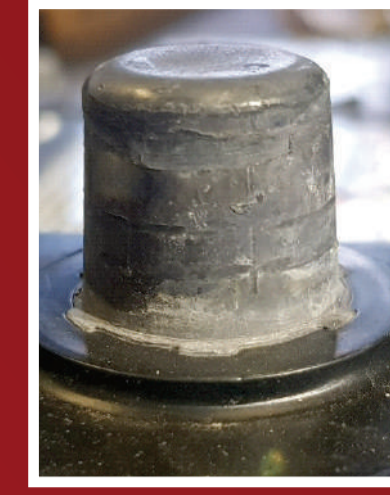
## EXAMPLES OF 2 YEAR OLD BATTERY POSTS USED ONLY FOR AUTOMOTIVE STARTING PURPOSES

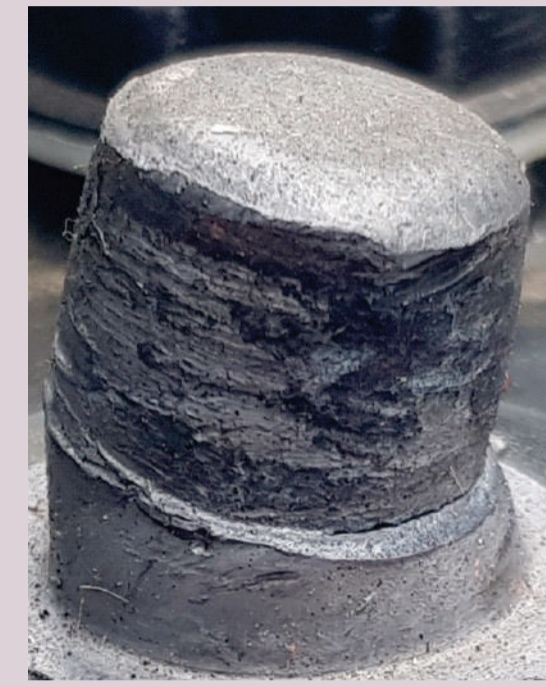
Post bend due to excessive force applied on post. This deformation may cause internal defects that can limit battery life

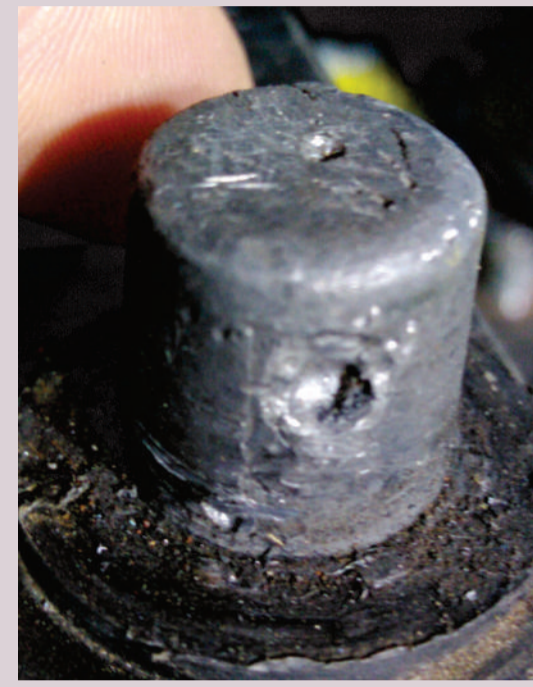
Hole drilled in post. This indicates that the battery was not only used for Automotive starting purposes and thus voids the conditions for warranty

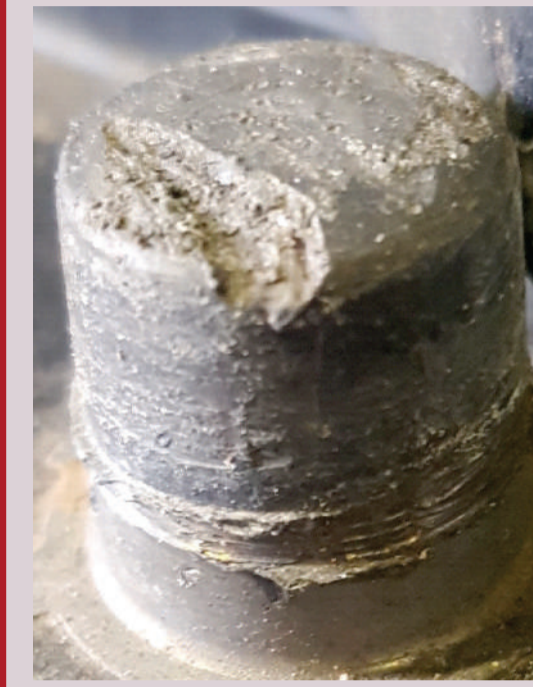
Led melted away due to sudden excessive current on top of post (Arc marks). This may cause high internal current that may reduce the lifetime of the battery

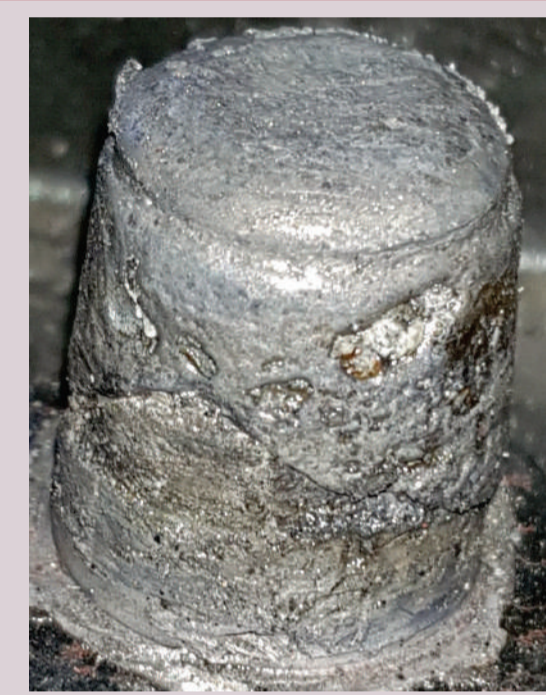
Lead re melted on top of post. This indicates rework done to the post that can cover a range of abuse

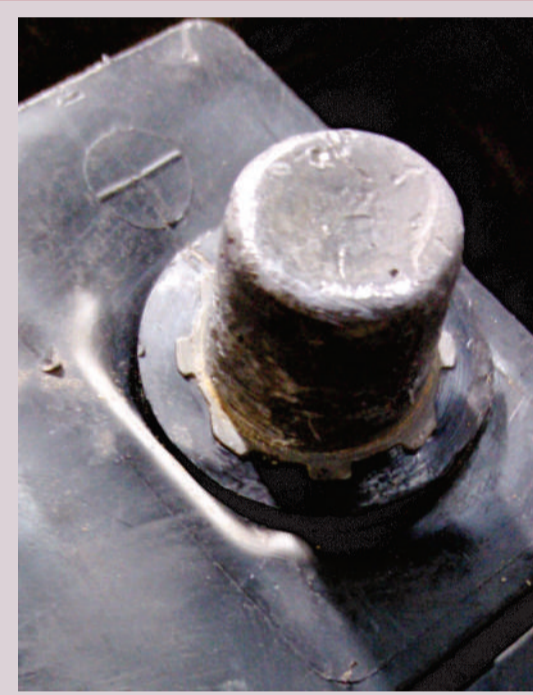
Excessive forces. It is visible from the battery casing that there has been excessive down force on the post that can damage the battery internally and reduce the lifespan of the battery

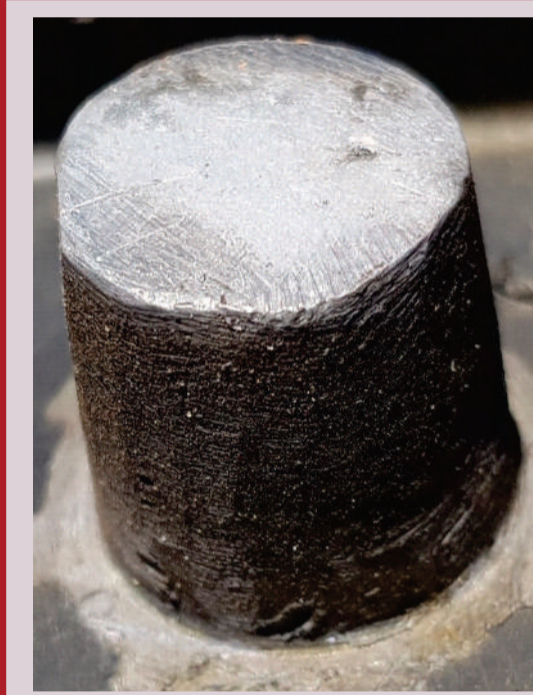
Reworked Post. The sharp edges and file/ sanding marks on the top and sides of the post indicate that the post was reworked and tampered with this voids the warranty

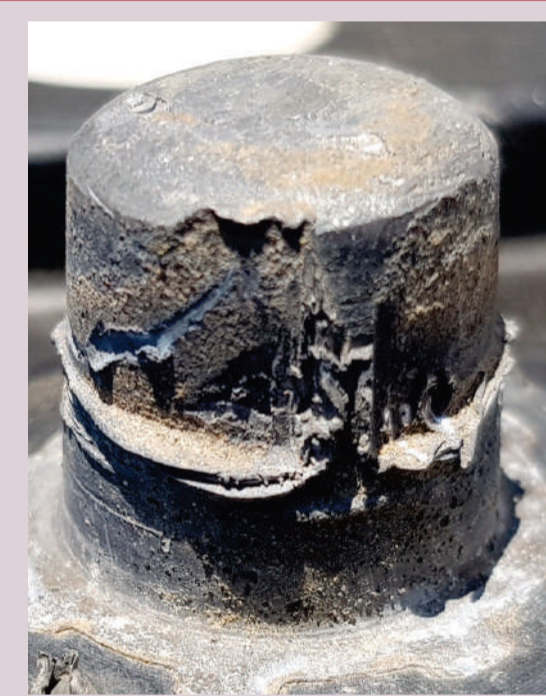
Battery terminal forced over post. These marks indicate that the battery terminal was smaller than the post and placed on the post with excessive down force creating the peeled lead marks and can cause internal damage that can reduce the battery lifetime

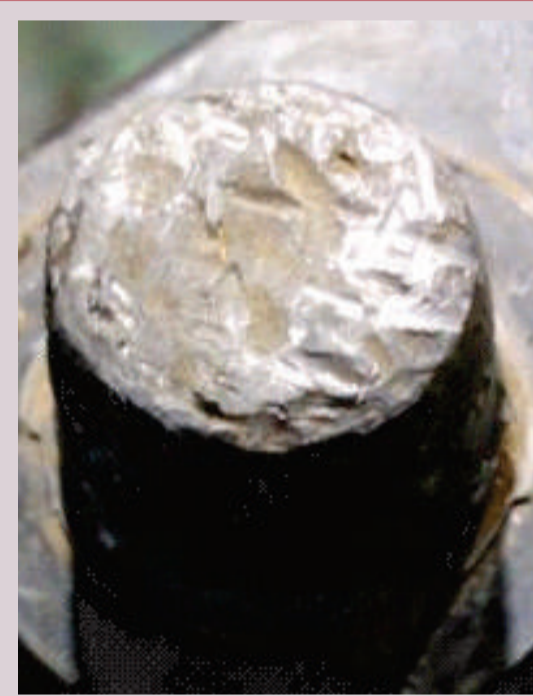
Indentations on the top of the post. This indicate "hammering" marks on the top of the post that can cause internal damage to the battery and reduce the lifespan of the battery

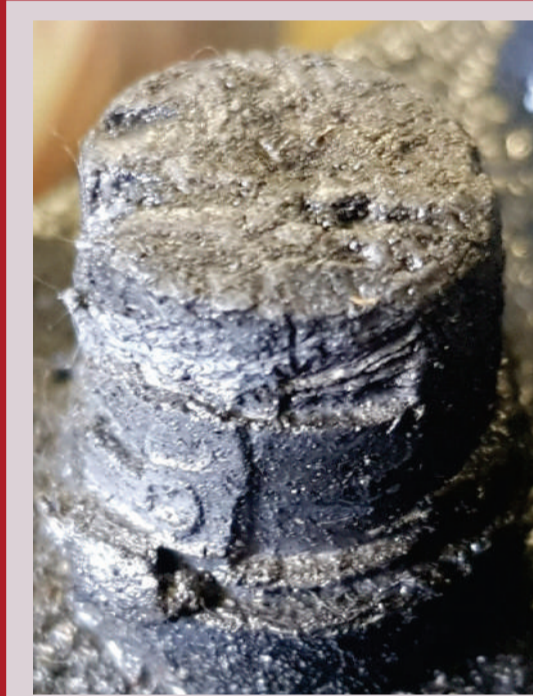
Re moulded post. This indicates that the post was tampered with and thus voids any warranty

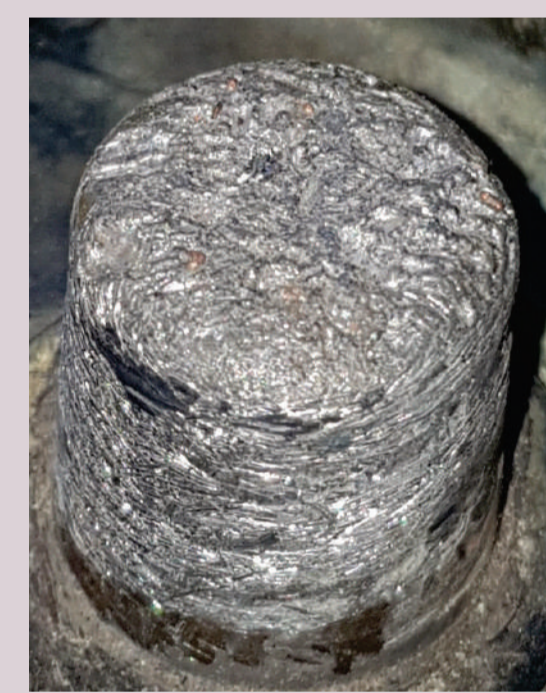
Marks on post. The marks are a clear indication that the battery was not only used for automotive starting purposes and thus voids any warranty

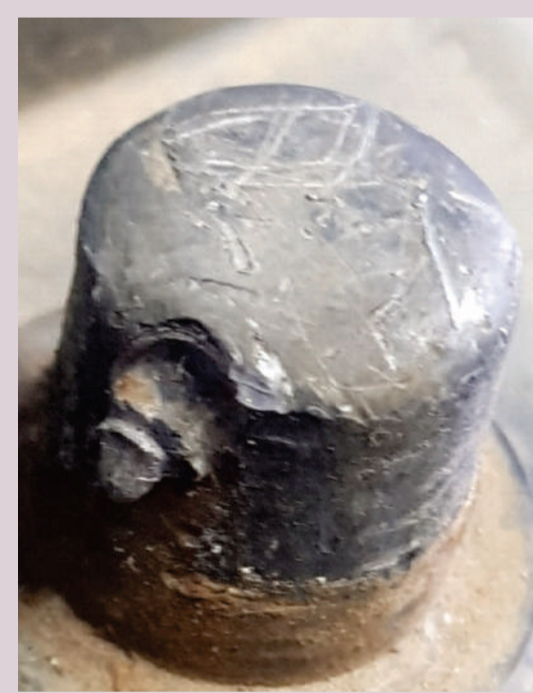
Reworked top of post. This indicate the hiding of abuse on the post and any rework marks will void the warranty

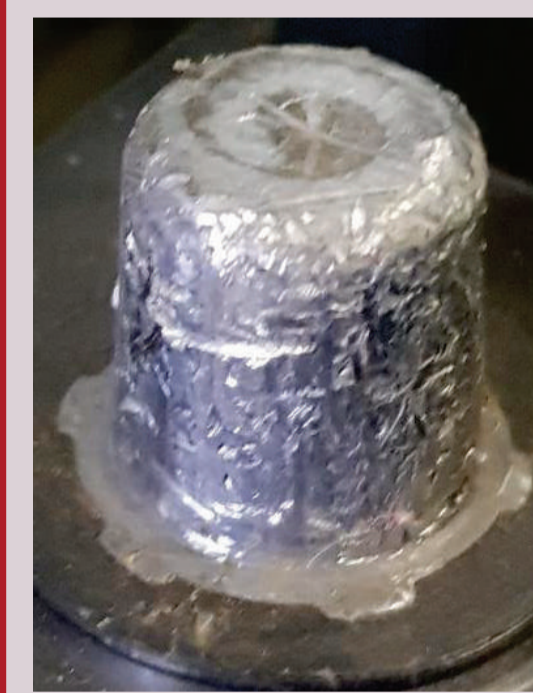
Post abuse marks. These marks indicate that the battery was not only used for automotive starting purposes as automotive battery terminals do not cause these marks under normal vehicle use

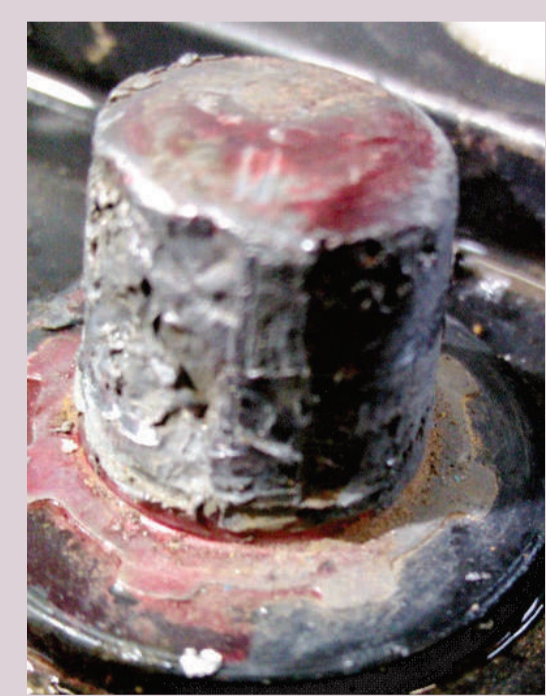
Marks on post. The marks are a clear indication that the battery was not only used for automotive starting purposes and thus voids any warranty

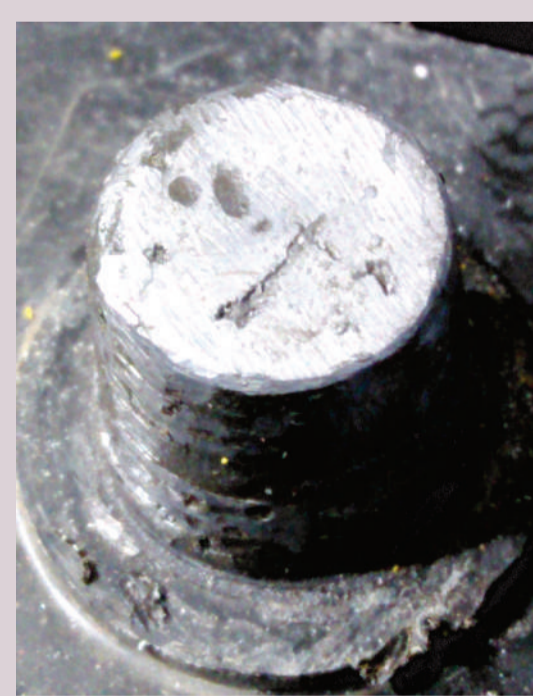
Reworked top of post. This indicate the hiding of abuse on the post and any rework marks will void the warranty

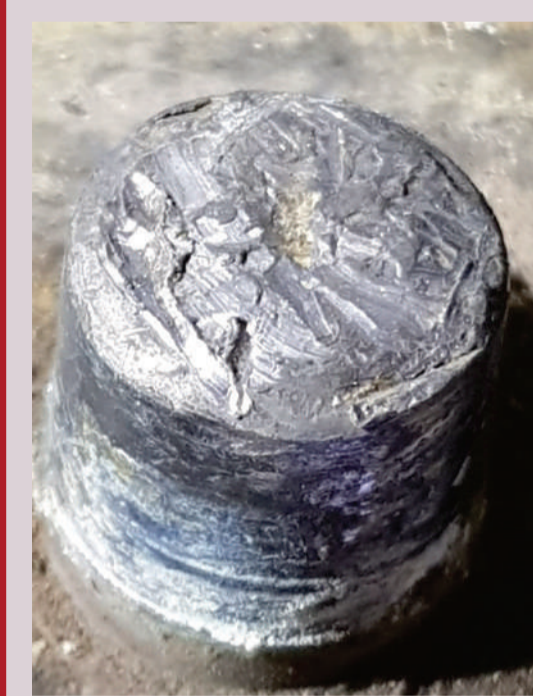
Post abuse marks. These marks indicate that the battery was not only used for automotive starting purposes as automotive battery terminals do not cause these marks under normal vehicle use
